**BEFORE THE STATE WATER  
RESOURCES CONTROL BOARD**

**EXHIBIT MPWMD-TC16**

**MONTEREY PENINSULA WATER MANAGEMENT DISTRICT**

**RIPARIAN CORRIDOR MONITORING REPORT  
CARMEL RIVER  
2007**

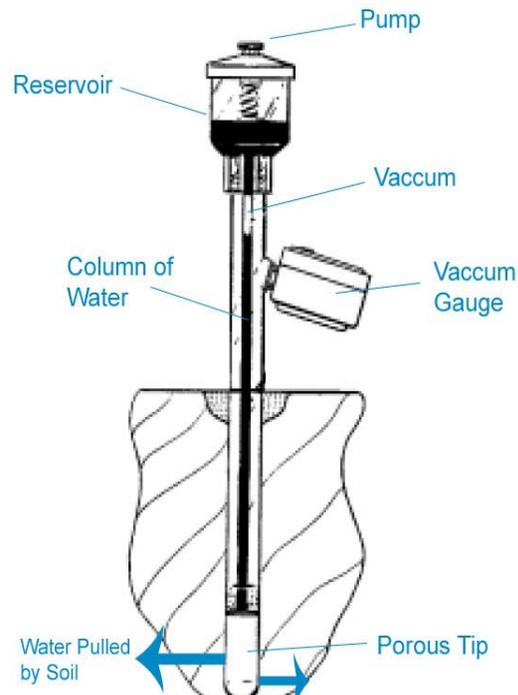
**Figure 2:** A tensiometer consists of a sealed tube, a porous tip, a vacuum gauge, and a reservoir pump. The tube is buried with the porous tip at the bottom and water is hand-pumped into the tube from the reservoir. Once the column of water in the tube is filled, the device is left alone. Over time, the soil pulls the water out of the tube through a porous tip. A vacuum gauge then measures the attractive forces of the surrounding soil on the water filled column.

Each station consists of two tensiometers buried so that the perforated ends are placed at 18 inches and 36 inches below the surface (Fig. 2). These stations are located at different elevations above the river (toe, mid and/or upper terrace) in order to measure soil moisture at that elevation. A gauge reading is recorded in centibars and algacide treated water is pumped into the column to reset the gauge. During this monitoring season some gauges failed either due to gauge malfunction or the vacuum was lost due to the liquid being completely pulled out of the reservoir.

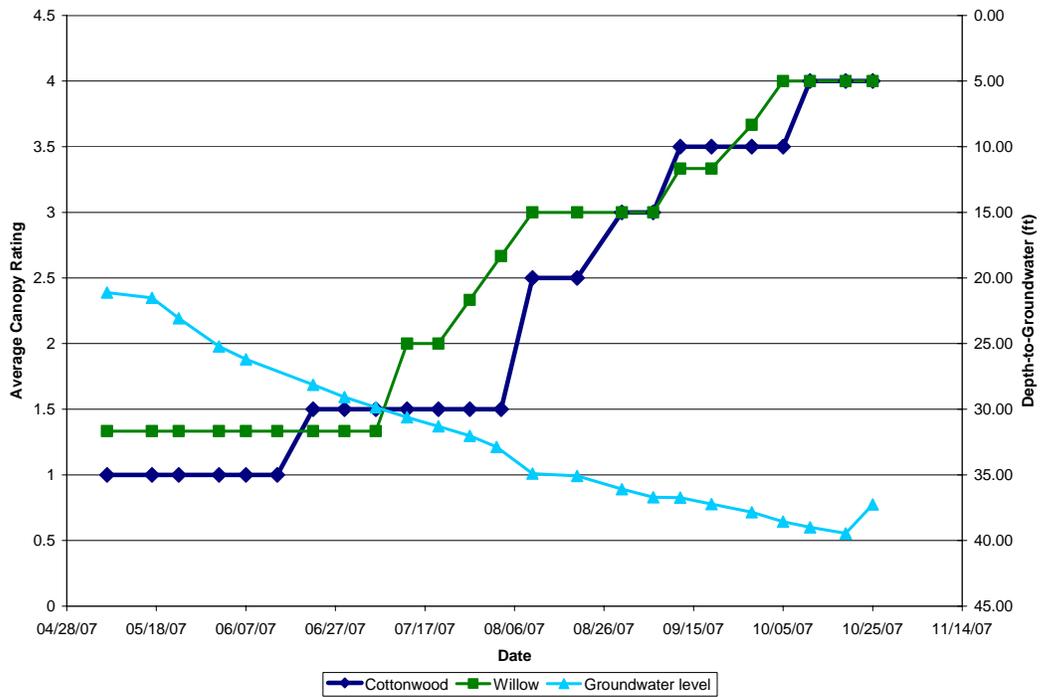
The monitoring season began with willows and cottonwoods having an AWCR of 1.3 and 1.0, respectively, and both ended the monitoring season with an AWCR of 4.0. The AWCR for willows steadily increased from early July through October. The AWCR for cottonwoods increased from 1 to 1.5 in late June and remained constant at 1.5 until early August when the AWCR increased to 2.5 (Fig.3). The cottonwood AWCR steadily increased through October.

From May through October the depth-to-groundwater at Cañada East groundwater monitoring well dropped a total of 16.14ft from 21.1ft to 37.25ft below surface. On November 25, depth-to-groundwater recovered 2.21ft from 37.25ft to 35.04ft because CAW shut down the Cañada production well for repairs (Fig.3). The greatest drop in depth was 2.03ft in 8 days.

**Figure 3: Average Weekly Canopy Rating for cottonwoods and willows at Cañada vs. depth-to-groundwater at the Cañada East monitoring well.**

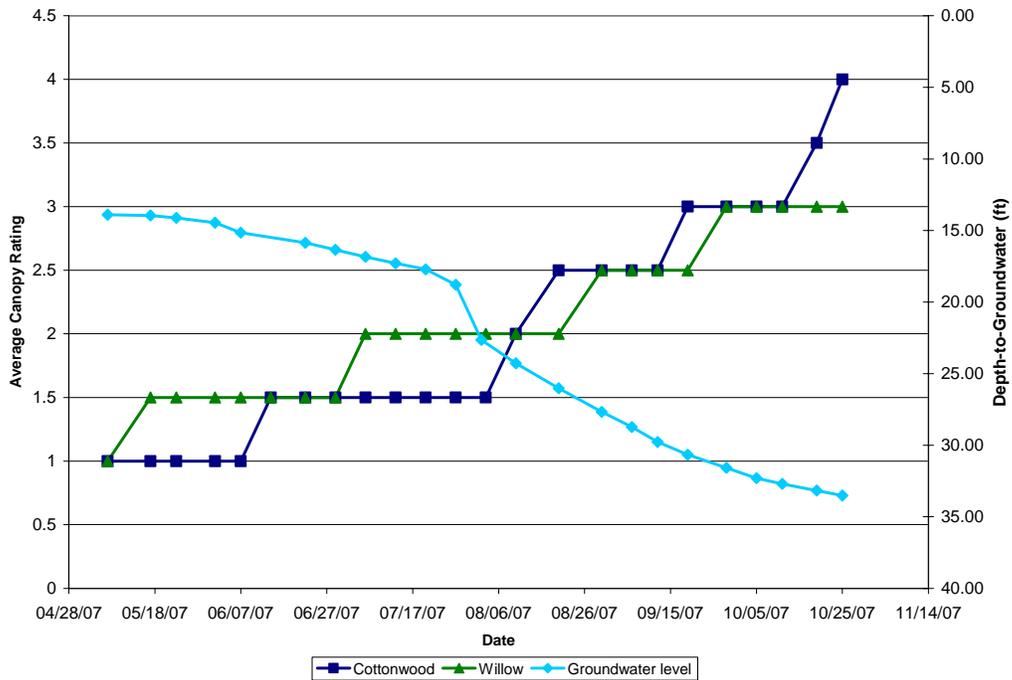
Willows and cottonwoods at the San Carlos site both began the monitoring season with an AWCR of 1.0 and ended the monitoring season with an AWCR of 3.0 and 4.0, respectively. The AWCR for willows increased within the second week of monitoring from 1.0 to 1.5. The AWCR increased again in late June (1.5 to 2.0), late August (2.0 to 2.5) and again in mid- September (2.5 to 3.0). The AWCR for cottonwoods increased from 1 to 1.5 in early June and stayed at 1.5 until early August when the AWCR increased to 2.5. The AWCR increased again in late September to 3.0 and then finally to 4.0 (Fig.4).

From May through October the depth-to-groundwater at San Carlos Deep monitoring well dropped a total of 19.61ft from 13.90ft to 33.51ft below the historical floodplain (Fig.4). The greatest drop in depth was 3.85ft in 6days.

**Figure 4: Average Weekly Canopy Rating for cottonwoods and willows at San Carlos vs. depth-to-groundwater at the San Carlos monitoring well.**

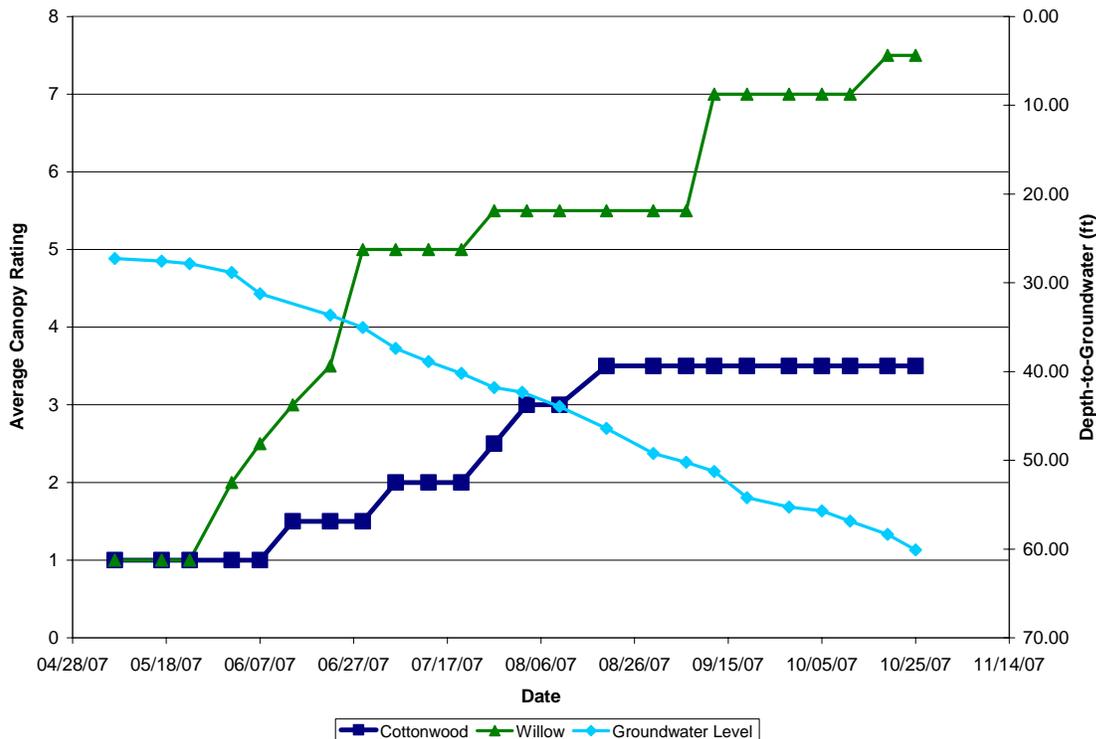
Monitored willows and cottonwoods both began the monitoring season with an AWCR of 1.0 and ended the monitoring season with an AWCR of 7.5 and 3.5, respectively. The AWCR for willows may be skewed due to an early dormancy or death of willow 00. The AWCR for willow 00 was 7.0 compared to an AWCR of 2.75 for Willow 99B. The AWCR for willows increased in late May from 1.0 to 2.0 and steadily increased until late June when the AWCR plateaued at 5.0. The AWCR increased again in late July to 5.5 and then again in early September to 7.0 and finally to 7.5 in October. The AWCR for cottonwoods increased from 1 to 1.5 in early June and stayed at 1.5 until early August when the AWCR increased to 2.0. By August AWCR for cottonwoods increased to 3.5. The AWCR for cottonwoods increased from 1 to 1.5 in early June and stayed at 1.5 until early August when the AWCR increased to 2.0. By August AWCR for cottonwoods increased to 3.5 (Fig.5).

The depth-to-groundwater at Williams South monitoring well dropped a total of 32.83ft from 27.27ft to 60.10ft below surface May through October (Fig.5). The greatest drop in depth was 2.34ft in 7days.

Figure 5: Average Weekly Canopy Rating for cottonwoods and willows at Valley Hills vs. depth-to-groundwater at the Williams South monitoring well.

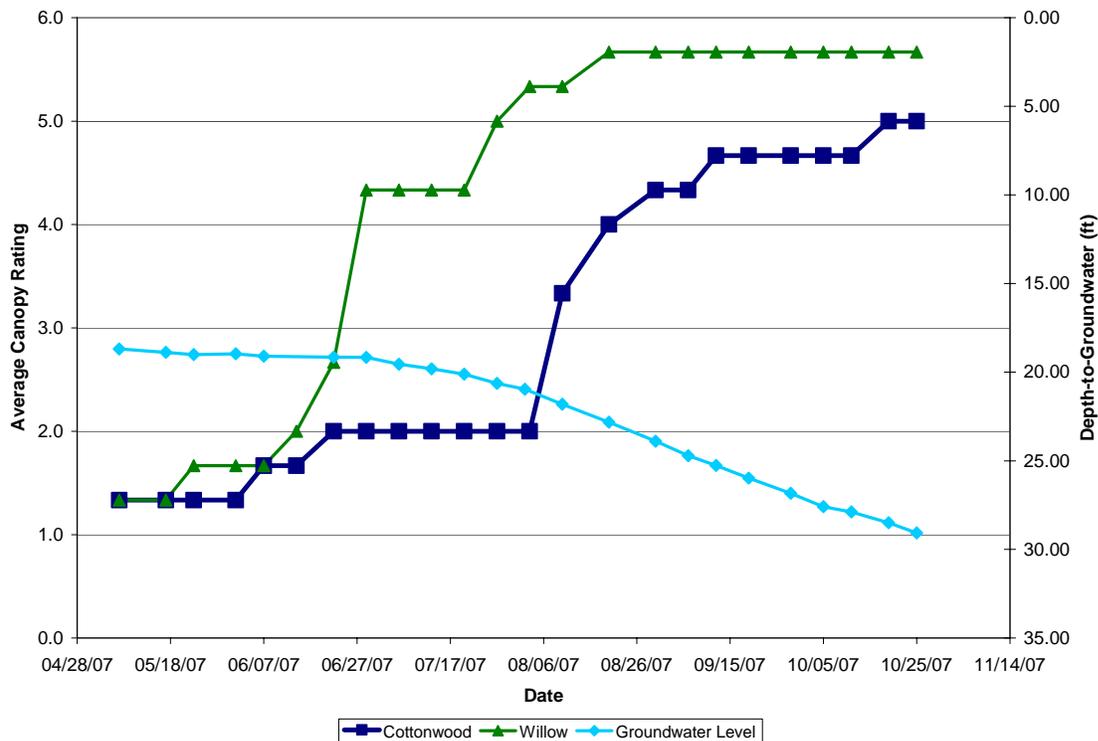
Monitored willows and cottonwoods both began the monitoring season with an AWCR of 1.3, and ended the monitoring season with an AWCR of 5.6 and 5.0 respectively. The AWCR for willows increased mid May from 1.3 to 1.7 and increased from 1.7 to 4.3 through June. The AWCR for willows increased again in mid-July to 5.0 and steadily climbed to an AWCR peak of 5.7. The AWCR for cottonwoods increased from 1.3 to 2.0 through June and stayed at 2.0 until early August when the AWCR began to increase to a peak of 5.0 in October (Fig.6).

May through October the depth-to-groundwater at Reimers monitoring well dropped a total of 10.38ft from 18.69ft to 29.07ft below surface (Fig.6). The greatest drop in depth was 1.07ft in 10days.

Figure 6: Average Weekly Canopy Rating for cottonwoods and willows at Schulte vs. depth-to- groundwater at the Reimers monitoring well.

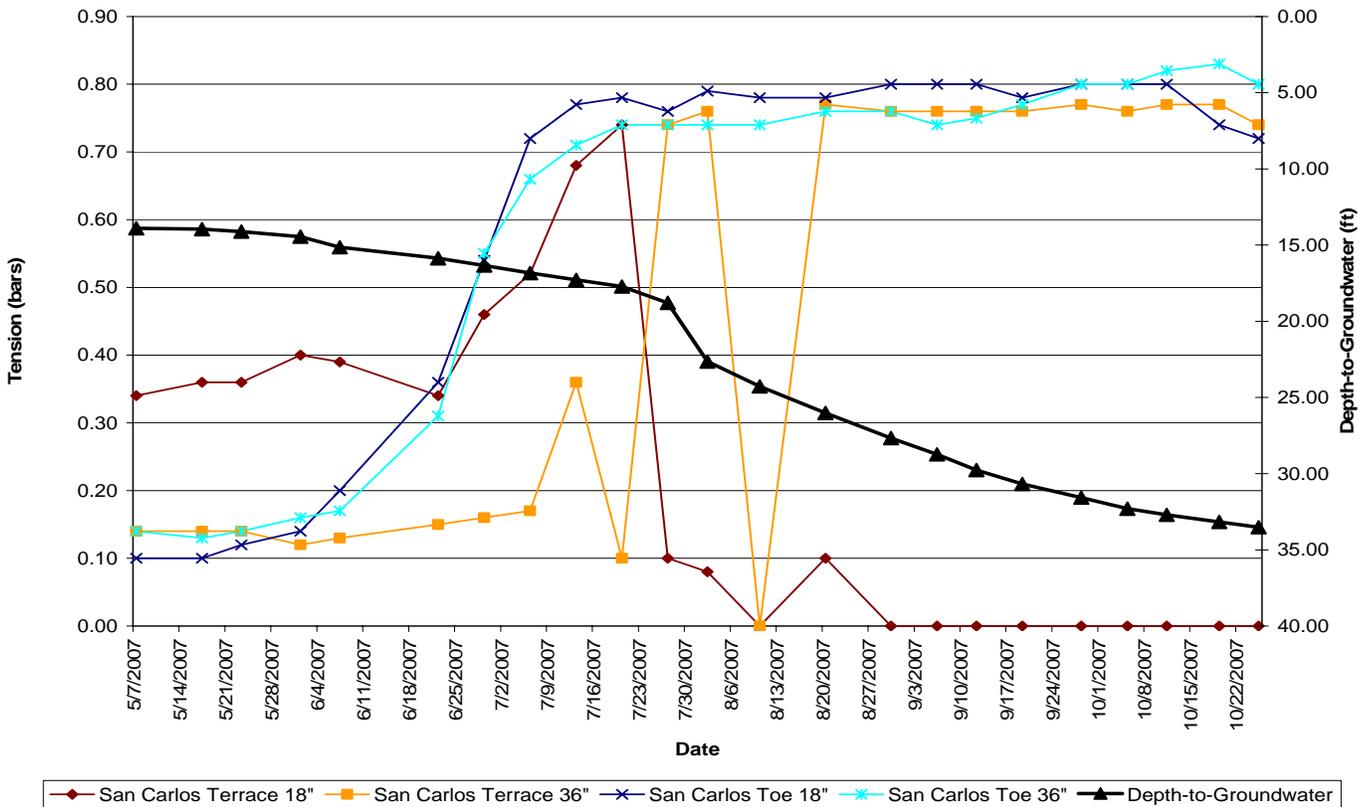
Tensiometer values at the toe (close to river channel bottom) began at approximately 0.10 bars (18") and 0.14 bars (36") in early May and rose steeply to 0.72 bars and 0.66

bars, respectively, by early July (Fig.7). Tensiometer values at the terrace (above river channel) began at approximately 0.34 bars (18") and 0.14 bars (36") in early May. In August the terrace 18" tensiometer was no longer functional. The terrace 36" tensiometer increased over the monitoring season to 0.78 bars.

At San Carlos, there is a good relationship between depth-to-groundwater and an increase in tensiometer values. Based on the data this relationship is apparent in August when all properly functioning tensiometers were between 0.70 and 0.80 centibars and the depth-to-groundwater had dropped 12.12ft to 26.02ft.

Figure 7: San Carlos toe and terrace tensiometer soil moisture values vs. depth-to-groundwater at San Carlos monitoring well.

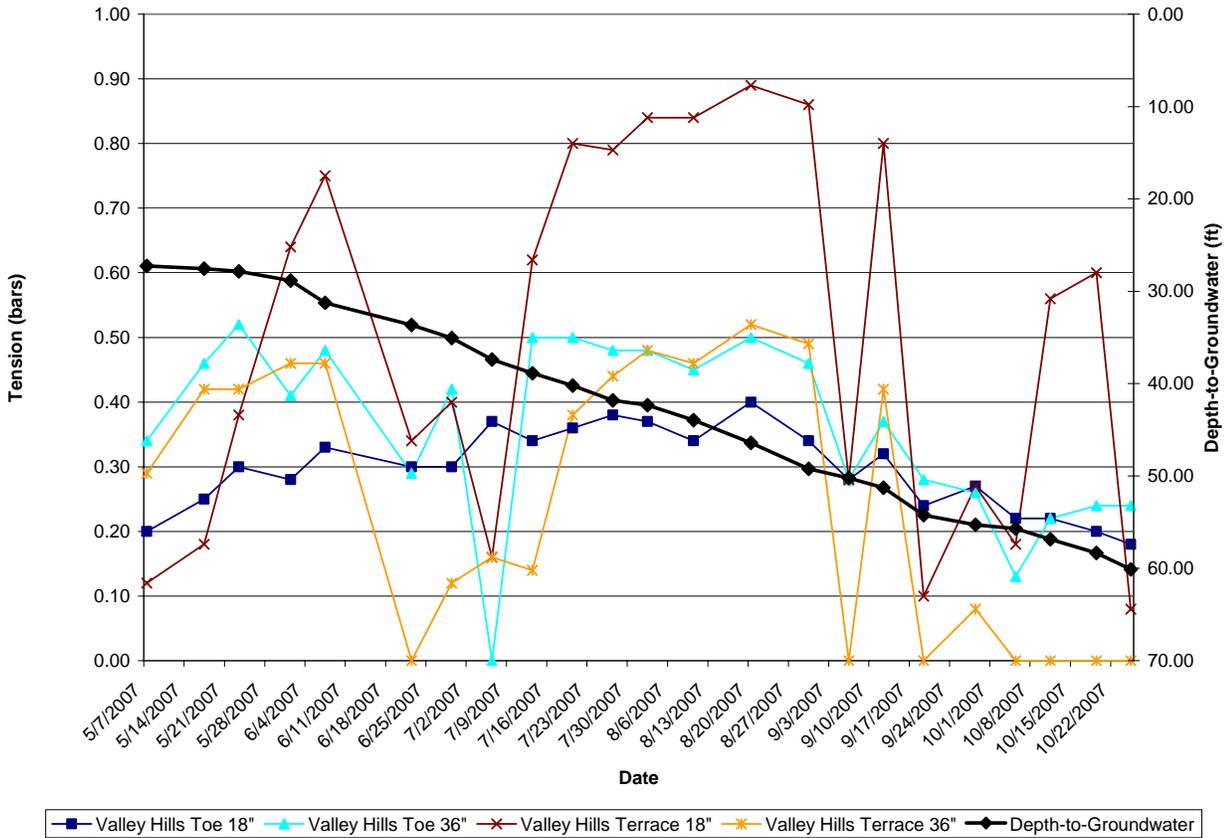
Tensiometer values at the toe (close to river channel bottom) began at approximately 0.20 bars (18") and 0.34 bars (36") in early May. The toe 18" tensiometer peaked at 0.40 bars and ended the season at 0.18 bars. The toe 36" tensiometer peaked at 0.50 bars and ended the season at 0.24 bars. Tensiometer values at the terrace (above river channel) began at approximately 0.12 bars (18") and 0.29 bars (36") in early May. The terrace 18" tensiometer peaked at 0.89 bars and ended the season at 0.08 bars. The terrace 36" tensiometer peaked at 0.52 bars and ended the season at 0.00 bars (gauge may have been broken; Fig. 8).

At the Valley Hills site conditions were dry and tensiometers often failed (vacuum tension broken and guage goes to 0 bars). This made it problematic so see the relationship between soil moisture and depth to groundwater. What we do know from the data is that soil conditions became very dry around mid June.

Figure 8: Valley Hills toe and terrace tensiometer soil moisture values vs. depth-to-groundwater at Williams South monitoring well.

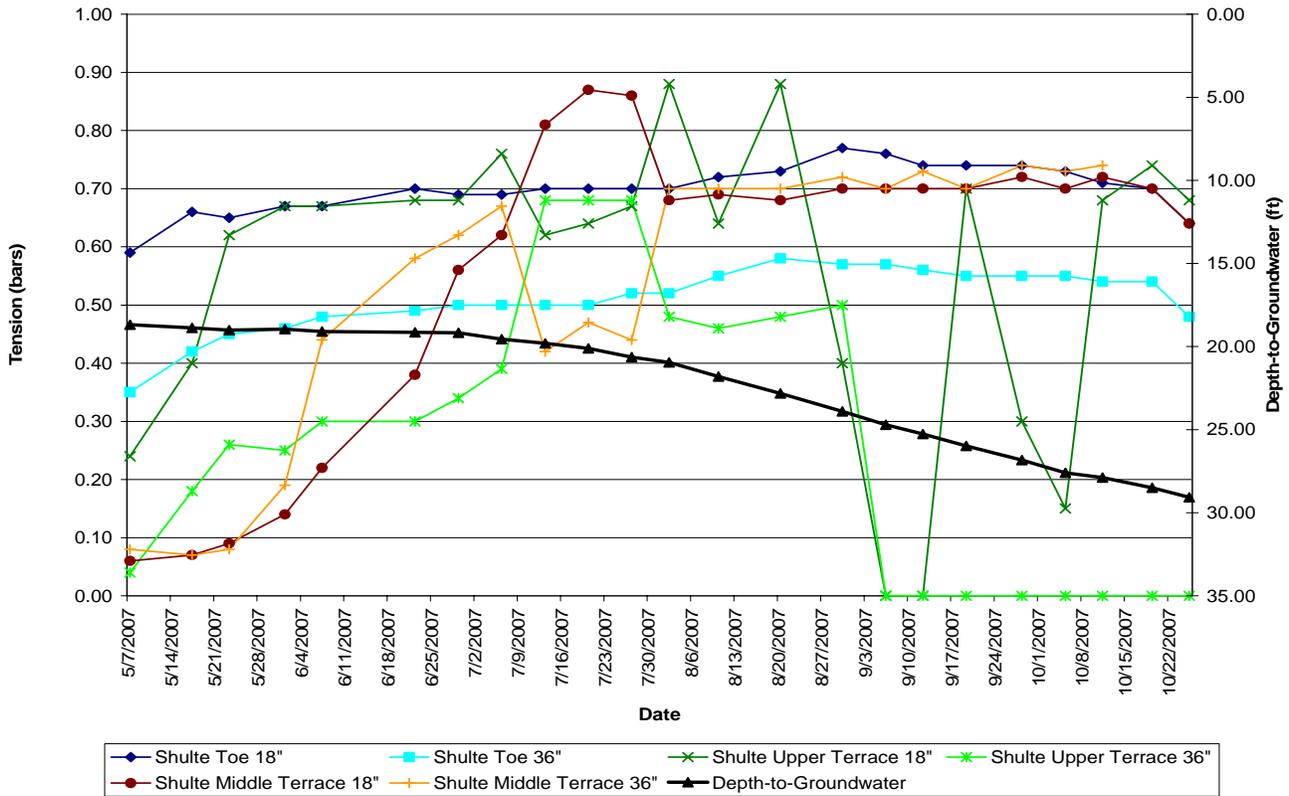
Tensiometer values at the toe (close to river channel bottom) began at approximately 0.59 bars (18") and 0.35 bars (36") in early May. The toe 18" tensiometer peaked at 0.77 bars and ended the season at 0.70 bars. The toe 36" tensiometer peaked at 0.58 bars and ended the season at 0.48 bars. Tensiometer values at the middle terrace (above river channel) began at approximately 0.06 bars (18") and 0.08 bars (36") in early May. The mid-terrace 18" tensiometer peaked at 0.87 bars and ended the season at 0.64 bars. The mid-terrace 36" tensiometer peaked at 0.74 bars and ended the season at 0.74 bars (Fig.9). Tensiometer values at the upper terrace (above river channel) began at approximately 0.24 bars (18") and 0.04 bars (36") in early May. The upper terrace 18" tensiometer peaked at 0.88 bars and ended the season at 0.68 bars. The upper terrace 36" tensiometer peaked at 0.68 bars and ended the season at 0.00 bars (gauge may have been broken).

At Schulte, there is also a good relationship between tensiometer values and the depth-to-groundwater where as the depth-to-groundwater increases so do the tensiometer values. This is apparent in August when all properly functioning tensiometers were between 0.64 and 0.88 centibars and the depth-to-groundwater had dropped 10.38ft to 29.07ft. This site also had failing tensiometers as the summer progressed and the soil dried out.

Figure 9: Schulte toe and terrace tensiometer soil moisture values vs. depth-to-groundwater at Reimers monitoring well.
